Manhole Inspection Summary

Manhole # S27I__039MH

Insp Date: **5/28/08 8:19 AM**

Location Address: **114 Parkin St**

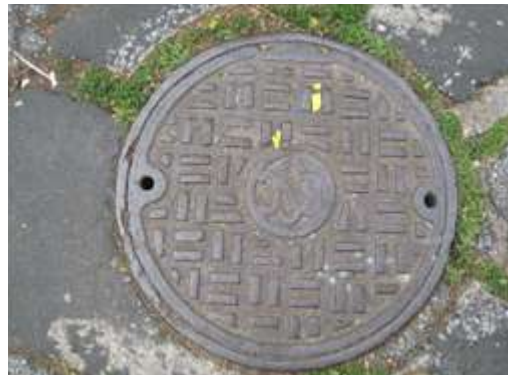
Cover View

Condition: **Sound**

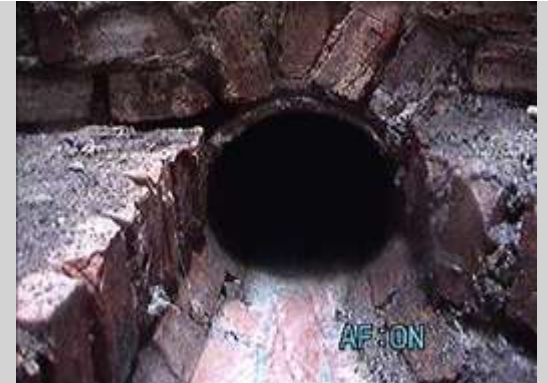
12 O'Clock Outflow

8 in. Circular Gravity Sewer
Pipe Out @ 12 O'Clock

Pipe Height: **8.4** (in.) Rod and Bar (Angled)
Pipe Material: **Clay** ☐ Pipe Lined
Invert Depth: **9.42** (ft.) Flow Characteristics: **Fast**
Deposits: ☒ None ☐ Mud ☐ Sludge ☐ Debris ☐ Grease
Silt Depth: **0** (in.) Deposits Extent:
Infiltration: **None** Pipe Seal Cond: **Sound**

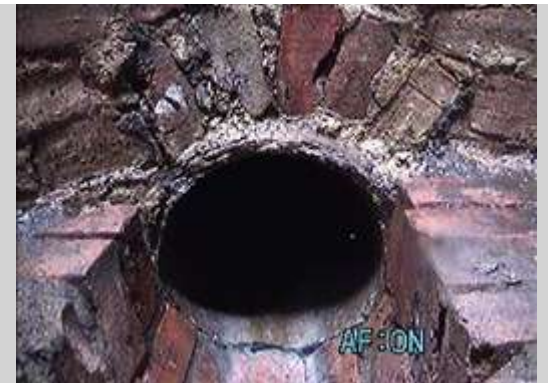
2 O'Clock Inflow

8 in. Circular Gravity Sewer
Pipe In @ 2 O'Clock

Pipe Height: **8.4** (in.) Rod and Bar (Angled)
Pipe Material: **Clay** ☐ Pipe Lined
Invert Depth: **9.28** (ft.) Flow Characteristics: **None**
Deposits: ☒ None ☐ Mud ☐ Sludge ☐ Debris ☐ Grease
Silt Depth: **0** (in.) Deposits Extent:
Infiltration: **None** Pipe Seal Cond: **Sound**

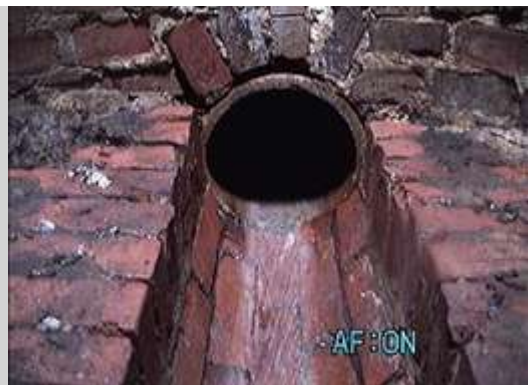
6 O'Clock Inflow

8 in. Circular Gravity Sewer

Pipe In @ 6 O'Clock

Pipe Height: **8.4** (in.) Rod and Bar (Angled)

Pipe Material: **Clay** ☐ Pipe Lined

Infiltration: **None** Pipe Seal Cond: **Unknown**
